EXPERIMENTAL ANALYSES FOR THE FLAWS CAUSED BY FIBER INSERTION AND STITCHING IN 3D PREFORMED T-JOINT CARBON FIBER REINFORCED POLYMER COMPOSITES USING X-RAY MICRO-COMPUTED TOMOGRAPHY

Zhang, H.^{1*}, Robitaille, F.^{2*}, Hassler, U.³, Joncas, S.⁴, Maldague, X.¹

Stitching can reinforce T-joint structure. However, T-joint and stitching might cause new types of internal flaws due to the characteristic of the structure. The corresponding study was poorly documented, especially using NDT. The purpose of this paper is to indicate internal flaws caused by T-joint and stitching in stitched 3D T-joint carbon fiber reinforced polymer matrix composites.

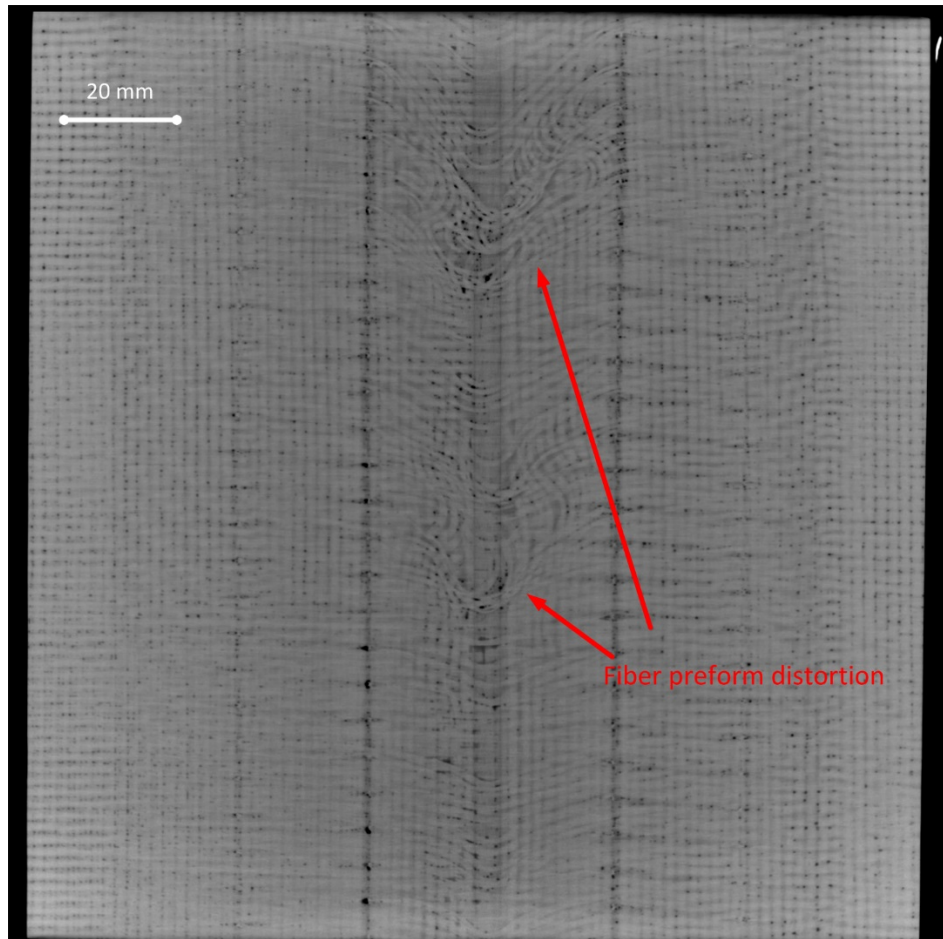
Under the 100 μm resolution overview inspection on the entire component, the fiber preform distortion was inspected on the T-joint zone. In Fig. 4, the coordinate system is marked y-z. The depth of the inspection in Fig. 4 is 4 mm (the distance to the flat surface, marked x-axis). The fiber preform distortion takes place from a depth of 3.4 mm to 4.6 mm (x-axis).

The potential cause of this type of fiber preform distortion is the interaction of the resin infusion and the T-joint structure. The fiber preform distortion can reduce the mechanical parameters of the entire component by causing fiber preform non-uniformity and resin redundancy in the partial zone. Caution in the procedure of the resin infusion regarding the T-joint structure is essential to the T-joint composite manufacturing.

Figure 4: The fiber preform distortion on the T-joint zone, depth: 4 mm (x-axis).

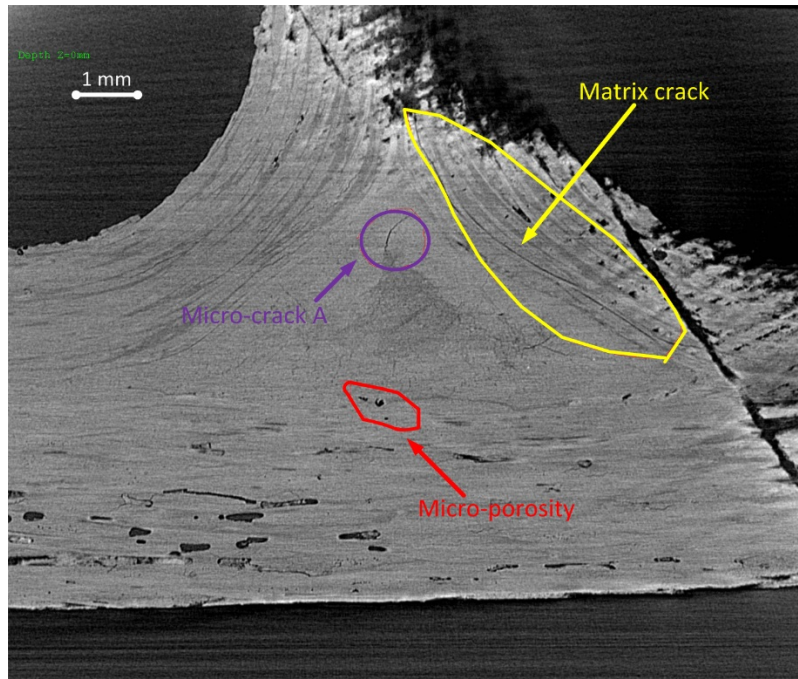
The first slice of the 8 μm micro-CT inspection is the T-joint surface (z-axis). The matrix cracks with yellow mark in Fig. 5 can only be inspected in the first 30 to 40 slices. Therefore, the cracks are evaluated as surface cracks. The depths (z-axis) of these cracks are from 0.24 mm to 0.32 mm.

The disparate type of vertical cracks with purple mark shown in Fig. 5 can be inspected in the entire thickness (z-axis) of the T-joint. The depth of the vertical crack A with purple mark in Fig. 5 is 0.64 mm (z-axis). In Fig. 6, two other vertical micro-cracks B and C are marked in purple. The inspection is from a depth of 0.712 mm (z-axis). The depth of the vertical micro-crack B is 1.04 mm (z-axis). The depth of the vertical micro-crack C is 0.96 mm (z-axis).

Figure 5: The 1 um high resolution inspection on T-joint zone, depth: almost near surface (z-axis).

The potential cause of the vertical micro-cracks in Fig. 5 and Fig. 6 is the stitching, which increase the tension in the T-joint. Cracking is one of the fatal flaws in composites manufacturing, which can reduce mechanical parameters critically. Caution in the procedure of stitching and the development of new stitching methods are essential to the T-joint composite manufacturing.

Some voids are inspected in this component. A few of these inspected voids are micro size, which are defined as micro-porosities. In Fig. 5 and Fig. 8, typical micro-porosities are marked in red. Fig. 8 is the inspection from the depth of 1.28 mm (z-axis).

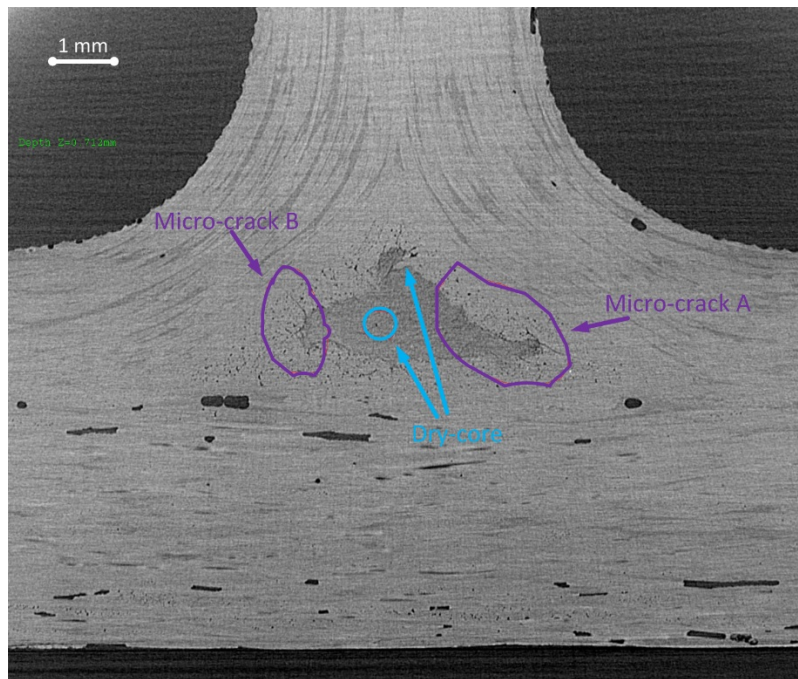
Figure 6: The 8 um high resolution inspection on the T-joint zone, depth: 0.712 mm (z-axis).

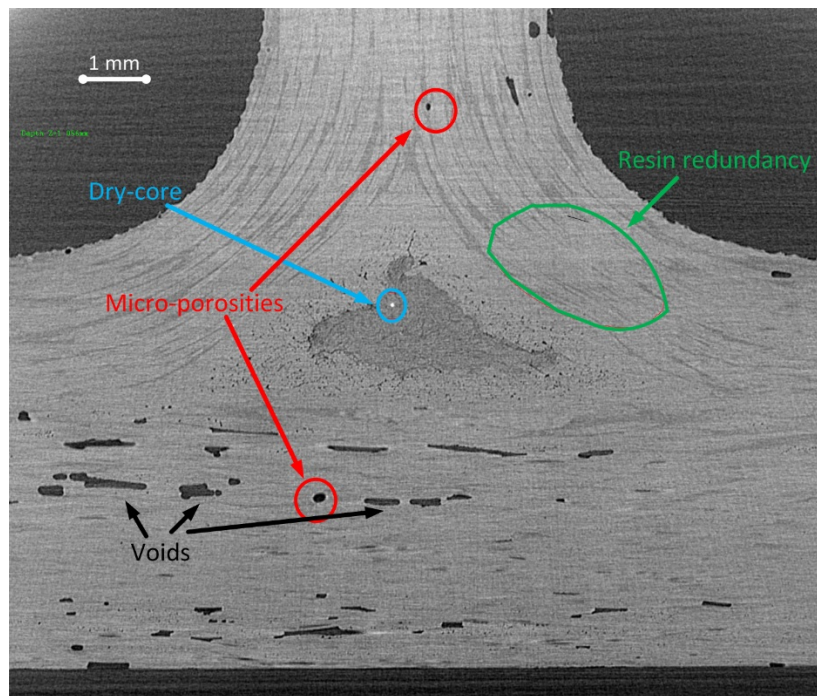
An essential consideration of stitching in this component is to reduce dry-core, which is caused by incomplete resin infusion of the noodle core. However, dry-core consisting of a few sub-micro-sized voids in the noodle is still inspected. These voids in the noodle are of sub-micro size, which is difficult to measure accurately. In Fig. 6 and Fig. 7, two larger voids in the noodle are marked in blue. Fig. 7 is the inspection from the depth of 1.056 mm (z-axis).

Figure 7: The 8 um high resolution inspection on the T-joint zone, depth: 1.056 mm (z-axis).

Resin redundancy is inspected in the T-joint zone. In Fig. 7, an evident resin redundancy zone is marked in green. Resin redundancy is also one of fatal flaws in composites manufacturing. The resin redundancy takes place more often in T-joint zone than in the flat zone. Therefore, one can conclude that the T-joint has an influence on the increase of resin redundancy.

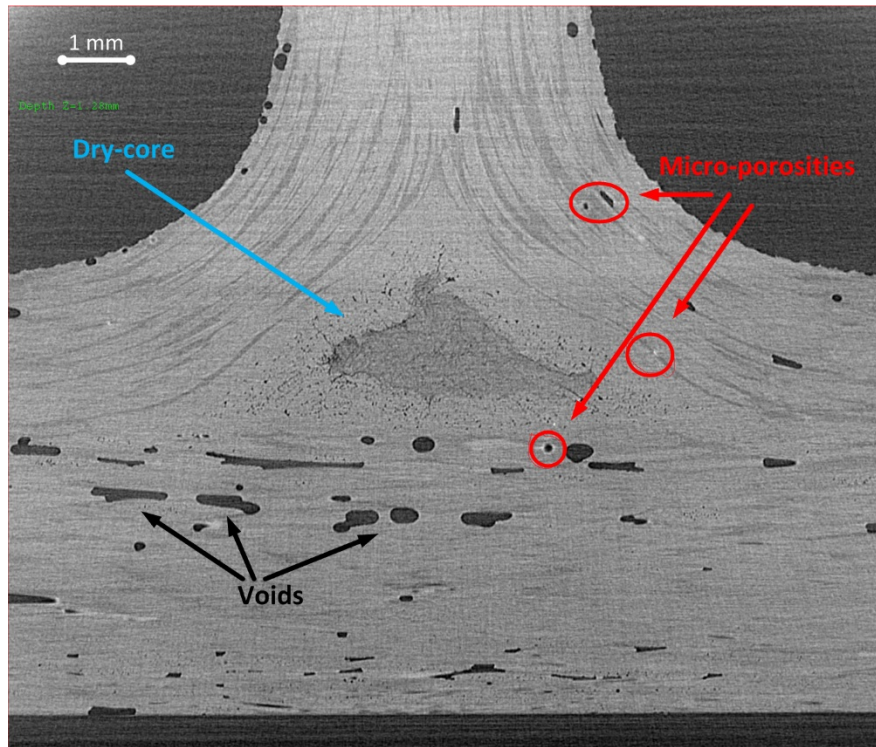
Voids and micro-porosities are essential flaws to composites manufacturing. However, it is difficult to conclude that T-joint and stitching cause the presence of voids and micro-porosities.

Figure 8: The 8 um high resolution inspection on the T-joint zone, depth: 1.28 mm (z-axis).
