FATIGUE BEHAVIOR OF A UNIDIRECTIONAL NON-CRIMP FABRIC GLASS FIBER REINFORCED REACTIVE THERMOPLASTIC COMPOSITE

Keywords: *Fatigue; glass fiber/reactive thermoplastic composites; damage evolution*

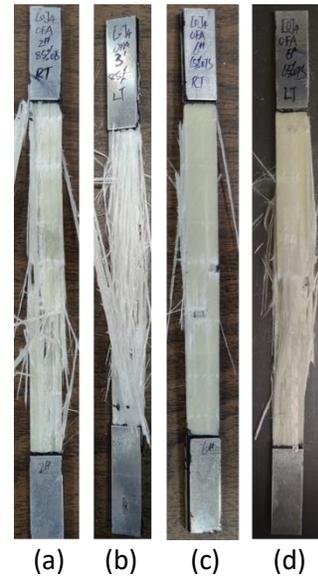
Figure 4. Typical failed specimens. (a) RT- 85% UTS; (b) -50°C - 85% UTS; (c) RT- 65% UTS; (d) -50°C - 65% UTS

Fatigue tests were conducted at maximum applied stress levels of 65% and 85% of the RT-UTS for both RT and -50°C test specimens until final failure occurred. The test conditions and results are listed in Table 2. At the same applied stress level, the average fatigue life at -50°C is at least 2X higher when compared with that at RT. The scatter of the fatigue life, represented using a coefficient of variation (CV), is greater at -50°C. These observations indicate the damage evolution process is affected to some extent by temperature, but the final failure mode seems to remain unchanged, as shown in Figure 4.

However, at peak cyclic stress of 65% UTS, the surface temperature was found to be more uniformly distributed compared with that of the 85% UTS samples, suggesting more localized damage, which can be demonstrated from the failed specimen in Figure 4. Additionally, no obvious splitting cracks were observed during the tests possibly because the threshold needed to drive crack propagation was not reached due to the lower stress values. Thus, the stress redistribution only affected the neighboring fibers close to the fiber break, decreasing the possibility of new fiber breaks, as can be seen in Figure 8. This can also explain why few fiber breaks occurred at lower stress levels (Figure 4).

Figure 4 also shows the difference in damage distribution between RT and -50°C fatigue samples. At -50°C, failure started at multiple individual locations, and there is less interaction between damaged regions. The damage evolution process is thus slowed down, and more regions exhibit damage, indicating more material bears the load and more efficient use of material, leading to longer fatigue life and damage tolerance.
