CANCOM2024 – CANADIAN INTERNATIONAL CONFERENCE ON COMPOSITE MATERIALS
**INTEGRATION OF INFRARED THERMOGRAPHY AND DIC FOR
DAMAGE CHARACTERIZATION IN NON-CRIMP FABRIC
REINFORCED POLYMER MATRIX COMPOSITES**

Keywords: *multiscale damage characterization ; digital image correlation ; infrared thermography*

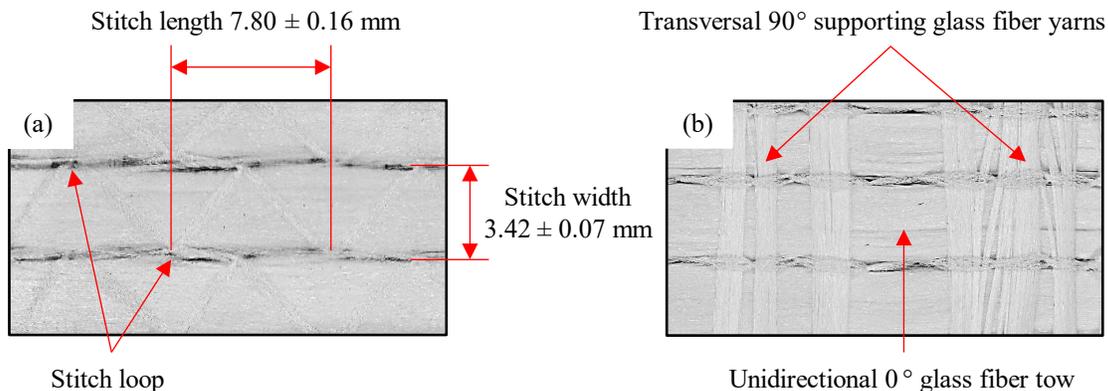
Fig. 1. Architecture of UD-NCF glass fiber layer: (a) top surface; (b) bottom surface[12].

The material used in this study consisted of a unidirectional (UD) glass fiber non-crimp fabric (NCF) embedded within a thermoset epoxy resin. The UD-NCF (Saertex Group, Germany) comprised 3.42 mm wide NEG 2026 glass fiber tows in the 0° (longitudinal) direction and sparsely distributed supporting glass fiber yarns oriented in the 90° (transverse) direction, with linear densities of 2400 tex and 275 tex respectively (Fig. 1). Axially knitted polyester yarns with a linear density of 110 dtex in a tricot pattern were utilized to stitch and align the 0° glass fiber tows. Consequently, the NCF had a total areal density of 943 g/m². The commercially available liquid Pro-set® epoxy resin (Gougeon Brothers, USA) was used in conjunction with an amide hardener (Pro-set® INF-211) in a weight ratio of 100:27.4, as recommended by the manufacturer. This material system was kept constant throughout all tests performed.

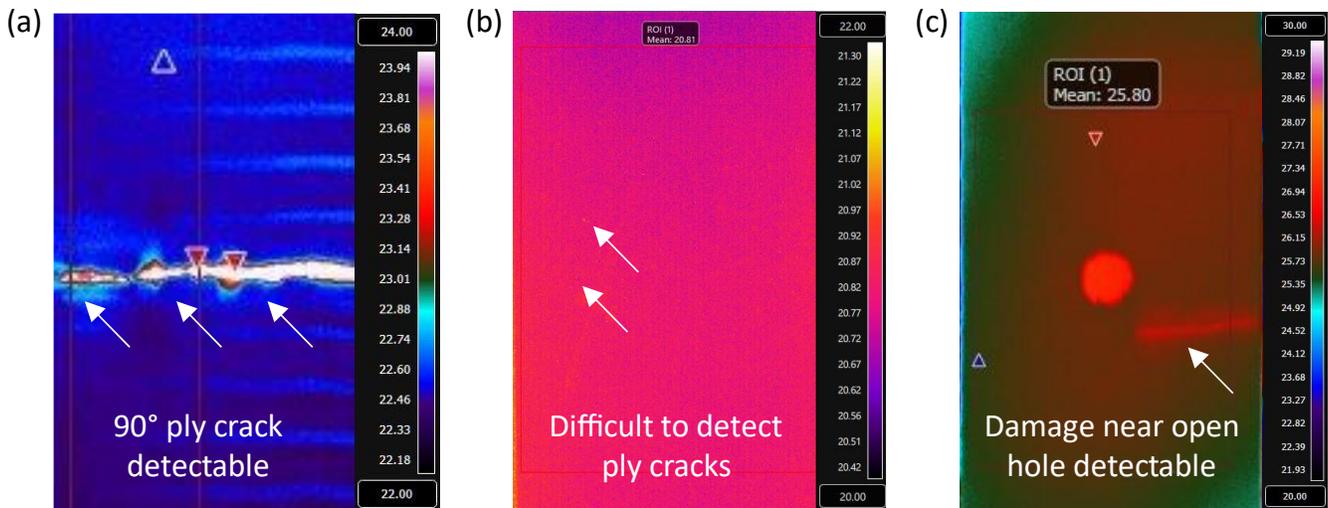
Fig. 2. Examples of thermographic images captured during preliminary test (displacement rate specified): (a) $[90]_4$ standard-width rectangular specimen (1mm/min); (b) $[0/90]_s$ standard-width rectangular specimen (2mm/min); (c) $[0/90]_s$ standard-width open-hole specimen (1mm/min).

All quasi-static tensile tests were conducted on a servo-electric Shimadzu test frame equipped with a +/-50 kN capacity load cell and hydraulic grips. Preliminary tests were performed on four standard-width rectangular specimens (25mm width) and five open hole specimens (hole diameter of 4.2 mm) with different stacking sequences under various displacement-controlled rates, ranging from 1mm/min to 2mm/min. These preliminary tests aimed to determine the minimum load required for damage initiation, consistently capture damage propagation, determine the optimum set-up parameters, and validate the developed NDE technique (refer to Fig. 2 for captured thermographic images). A reduced-width $[0/90]_s$ rectangular specimen in accordance with ASTM 3039 [13] (15mm width x 275mm length) loaded at a displacement rate of 1mm/min was chosen in this study to ensure onset of damage at a lower applied load and potentially reduce the rate of damage propagation, enabling the characterization of damage. A total of three tests were performed using the reduced width specimens, which showed consistent results.

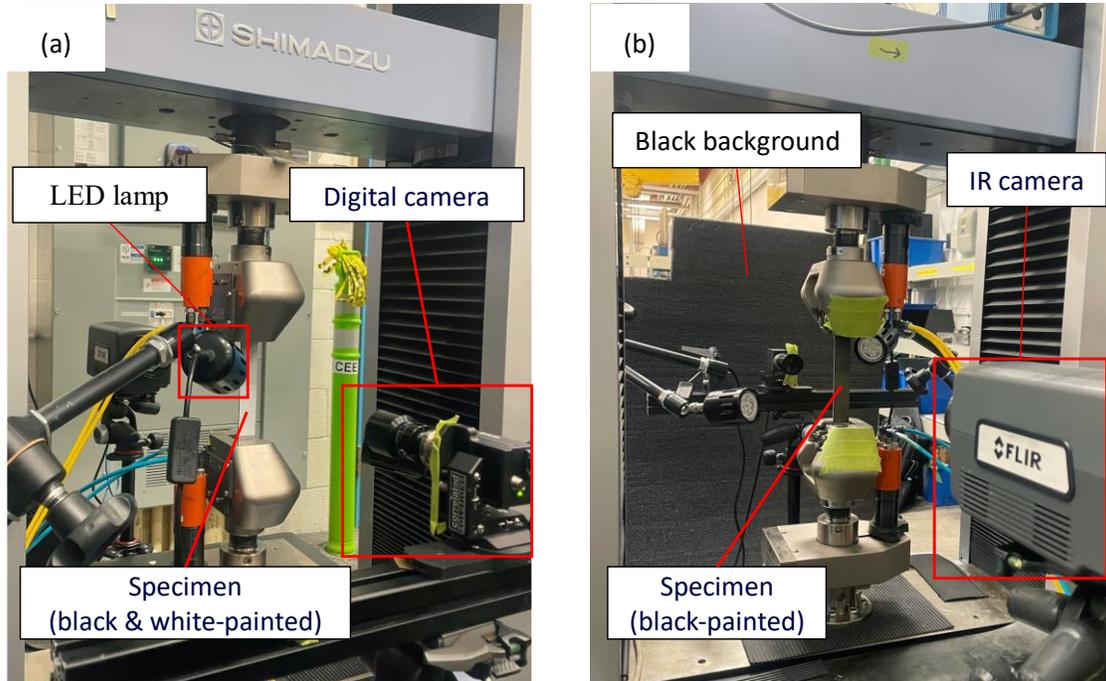
Fig. 3. Test set-up: (a) front view; (b) back view.

A 5MP resolution digital camera was used on the mold side of the specimen to capture images at different applied displacements at a frame rate of 5Hz (Fig. 3a). The region of interest (ROI) was located at the center of the specimen gauge length and was finely speckle patterned with black and white spray paint. VIC-2D software was employed to determine the strain and displacement fields, which could be correlated to damage events. A subset size of 29 pixels, step size of 7 pixels, and filter size of 12 were used to calculate the strain maps within the ROI, while a virtual extensometer with a length of 20 mm was used to evaluate the average strain for stress-strain plots.

The FLIR A8581 IR camera with a pixel resolution of 1280 x 1024 and a temperature sensitivity of <25 mK was positioned on the opposite side of the specimen to monitor the surface temperature variations during testing (Fig. 3b), which could be correlated to damage events. FLIR Research Studio was used to postprocess the thermographic videos. To maximize heat emissivity and better capture thermal radiation, several approaches were employed according to the results from the preliminary tests: 1) a black background screen was used; 2) the specimen side facing the camera was sprayed with a black matte paint; 3) a precision optics was used to zoom in the field of view

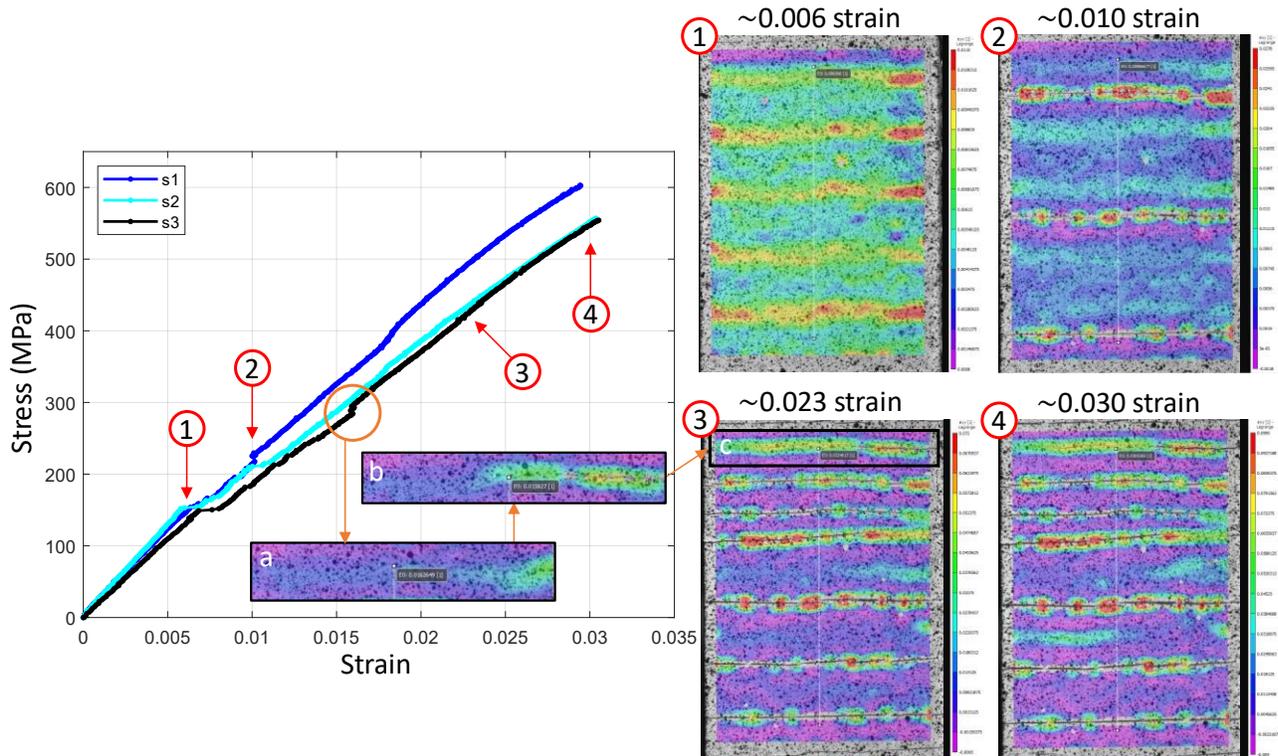
Fig. 4. Stress-strain response and damage characterization using DIC for a reduced width $[0/90]_s$ specimen.

Fig. 4 shows the material stress-strain response and strain contour maps at indicated strain levels in a sequential manner. The specimen exhibited a bi-linear stress strain response with a transition at ~ 0.006 strain. With further increase of the load, no evidence of plastic deformation was observed up to failure at ~ 0.030 strain. The damage evolution was also examined from the surface strain development. 90° fiber tow cracks were first observed at several locations along the specimen length at 0.006 strain (Fig. 4.1), which correlated well with the knee point observed in the stress-strain curves. A local maximum strain of 0.012 was observed at the cracked regions near the specimen edge. At ~ 0.010 strain (Fig. 4.2), 90° fiber tow cracks tended to propagate along the fiber direction across the entire width of the specimen. With further increase of the load (~ 0.023 strain, Fig. 4.3), additional 90° fiber tow cracks developed, and crack saturation was reached where crack spacing was uniformly distributed along the specimen length. A detailed illustration of a single crack propagation (a \rightarrow b \rightarrow c) during this stage further validated the initiation location of 90° fiber tow cracks. The maximum local strain was ~ 0.072 and there was no indication of other damage modes, such as 0° fiber tow cracks and large-scale delamination. The strain contour did not change significantly prior to the final failure of the specimen (~ 0.030 strain, Fig. 4.4).

Although same specimen was used to compare the damage evolution process using DIC and IRT, the contour maps of strain and temperature were different (i.e., Fig. 4.1 versus Fig. 5b at ~ 0.006 strain). Several possible reasons could cause this discrepancy. First, the digital and IR cameras were facing opposite sides of the specimen and the development of damage may have been distinct among different fiber layers. Fig. 6 shows the microscopic results of 90° fiber tow cracks developed at different layers by Shi et al. [12]. Two damage events were observed: 1) cracks propagated within their fiber tow in the same layer (Fig. 6a); 2) cracks coalesce between fiber tows in adjacent 90° fiber layers (Fig. 6b). Second, DIC allowed for the calculation of strain contours from specimen surface displacement, while IRT was able to capture the dissipated heat resulting from the initiation and propagation of damage even in

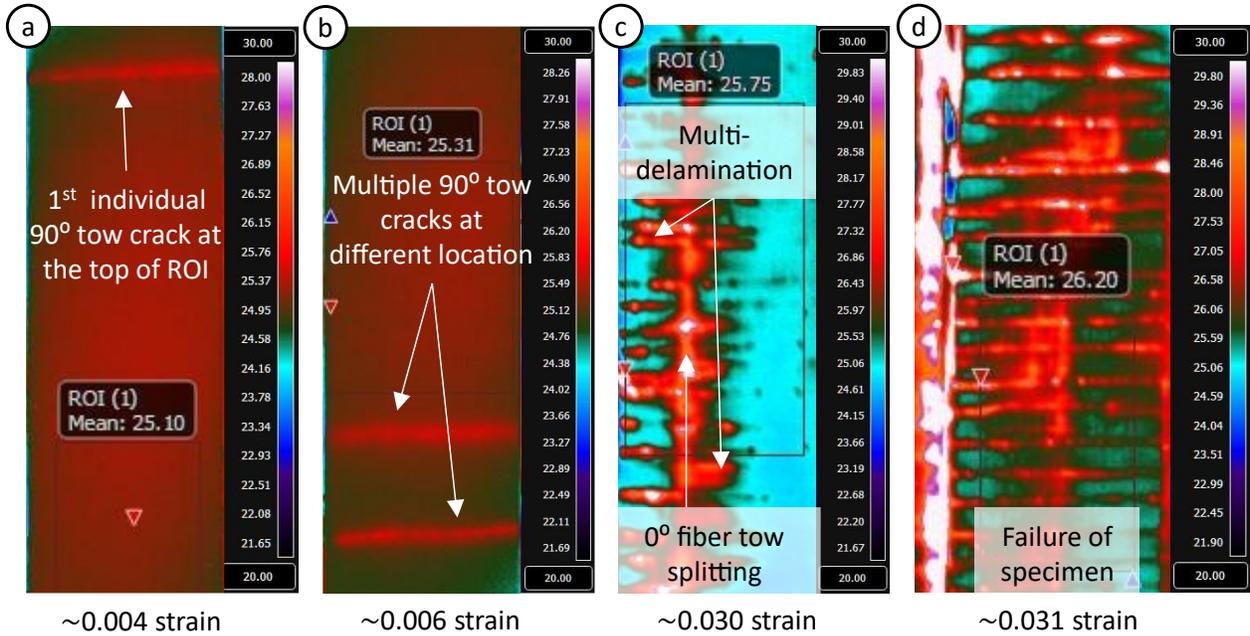
Fig. 5. Damage characterization using IRT at different applied stress for a reduced width [0/90]_s specimen.

Fig. 5 shows the damage evolution process captured using IR thermography for the same specimen. The first individual 90° fiber tow crack was observed at a much lower strain of ~ 0.004 (Fig. 5a), which did not cause a kink in the stress-strain plot (Fig. 4) or a significant change in the secant modulus. The onset of the first individual 90° fiber tow crack may have been a result of localized manufacturing defects (e.g., voids). Moreover, the temperature variation due to crack initiation at the inner 90° fiber layers was less than 0.5°C compared to the undamaged region. As loading increased until ~ 0.006 strain (Fig. 5b), multiple 90° fiber tow cracks were observed at different locations along the specimen length, corresponding to the significant drop of the load (Fig. 4). This observation also correlated well with the results obtained using DIC. With further increase of the load prior to failure, ~ 0.030 strain (Fig. 5c), more damage modes were observed, such as multiple localized delamination cracks propagating along the 90° fiber tow peripherals in the longitudinal direction and 0° fiber tow splitting cracks. These critical damage modes could interact with each other, leading to the final failure of the specimen at ~ 0.031 strain (Fig. 5d).

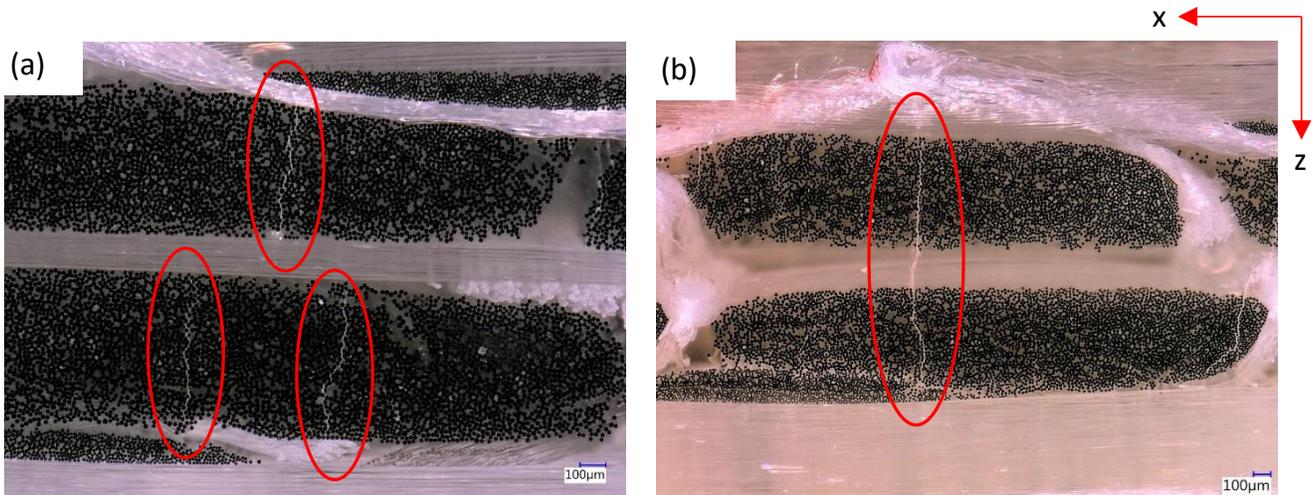
Fig. 6. Microscopic observation of 90° fiber tow cracks a) at different 90° fiber layers; b) across adjacent 90° fiber layers [12].
