# EFFECT OF SURFACE TREATMENT AND ADHEREND MICROSTRUCTURE ON THE FRACTURE TOUGHNESS OF ADHESIVE BONDED NCF COMPOSITES

**Keywords:** *CFRPs; adhesive bonding; toughness*

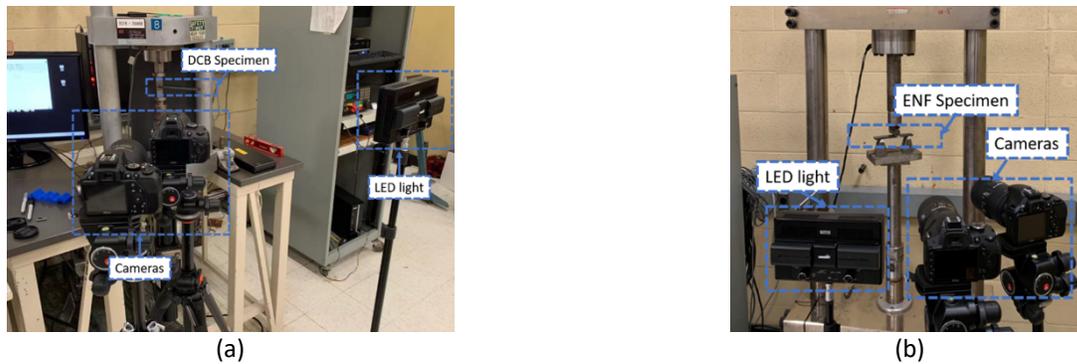
Figure 1. Experimental set-up employed employed in the present study and available at University of Waterloo E3-2106. (a) DCB and (b) ENF tests. The servo-hydraulic test frame was provided with an MTS Flex Test SE controller.

DCB and ENF tests were conducted using CFRP substrates obtained by cutting composite plates with an abrasive water jet cutter and treated as described in Section 2.2. These substrates, with dimensions of length  $L=140$ mm and width  $B=25.4$ mm, were individually prepared and joined in a mold using the toughened epoxy adhesive. Bondline thickness was maintained at 0.25 mm using shims, positioned at the starter-crack region and the test sample's end. After removal from the mold, excess adhesive was cleaned from the side surfaces, which were then painted white with vertical lines to aid visualization of crack growth. For DCB testing, loading blocks were bonded onto CFRP surfaces using a fast-curing adhesive (LOCTITE 480 PRISM). Mechanical tests utilized a servo-hydraulic test frame with an MTS Flex Test SE controller. A test frame provided with a 2.2 kN load cell was used for DCB tests, while for ENF tests, the three point bending fixture was mounted on a frame provided with a 5 kN load cell. An overview of both test set-up is shown in Fig. 1 [2]. CCD cameras were used to monitor crack propagation

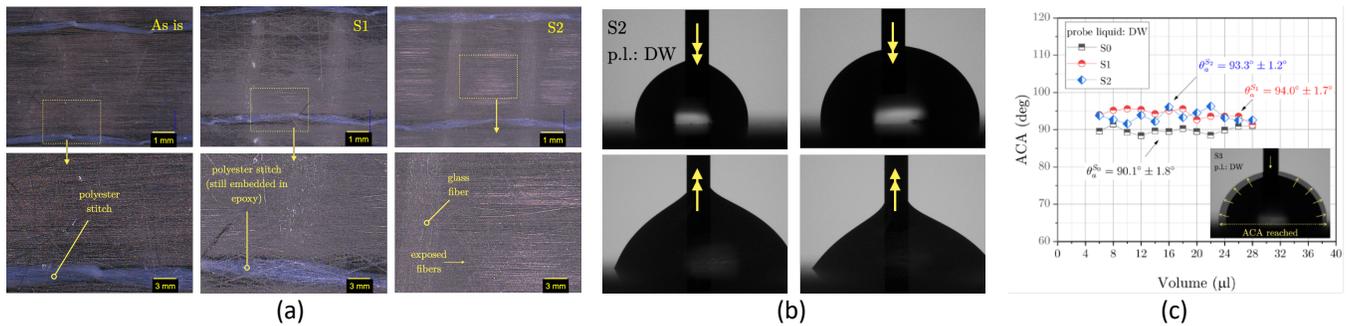
Figure 2. (a) Optical microscopy images of the composite surface before and after sanding. (b) Snapshots taken during measurement of advancing (top) and receding (bottom) contact angles on surface S2. (c) Advancing contact angles as a function of the droplet volume (after corrections using Wenzel’s equation [2]). Probe liquid: distilled water.

Microscopy images of the treated surfaces are shown in Fig. 2(a). The original as-produced surface (“as is”) appears relatively smooth, and the presence of polyester stitches can be readily observed from visual inspection since the epoxy matrix was optically translucent. After sanding (S1), the stitches seem to be still embedded within a thin epoxy layer, while the glass fibers become more visible. With prolonged standing (S2), the glass fibers are further exposed, and so are the carbon fibers, although they appear to be well anchored to the epoxy matrix.

To further assess the surfaces before bonding, the wettability was analyzed using A.C.A. and R.C.A. [6]. As shown in Fig. 2(b), the R.C.A. was somewhat difficult to determine with accuracy because the contact line remained pinned until the receding angle was too small to be measured accurately. Instead, the A.C.A. was most reproducible, also with respect to the static measurement. The A.C.A. values for S0, S1 and S2 are reported in Fig. 2(c). The inset figure shows the superposition of two snapshots that highlight the movement of the contact line and the achievement of the A.C.A.. Interestingly, the A.C.A. of all samples is relatively stable and increases slightly after sanding. The average values, which are included in Fig. 2(c) indicate that the initial hydrophobic surface remains so after sanding. A potential reason for such behavior could be associated to the polyester stitches used to hold the layers of the non-crimp fabric. These may create discontinuities in the surface, making it challenging for epoxy adhesives to wet the substrate uniformly. Moreover, glass fibers and polyester stitches may have different chemical

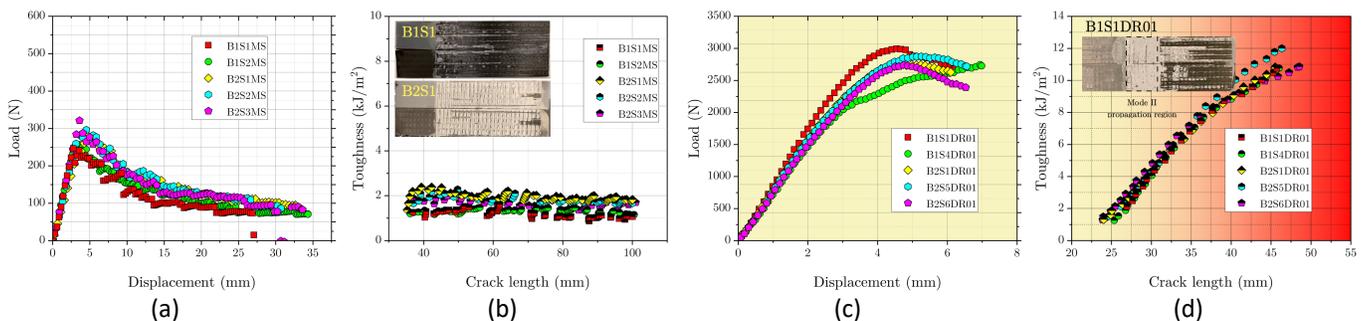
Figure 3: (a) Load-displacement responses recorded in DCB tests; MS stands for manual sanding. (b) R-curves determined in DCB tests. (c) Load-displacement curves recorded in Mode II fracture tests; DR01 stands for displacement rate at 0.1 mm/s. (d) R-curves determined in ENF tests. The insets show instances of DCB and ENF fractured surfaces.

The load-displacement responses and R-curves of DCB specimens treated with sanding are depicted in Fig. 3(a) and (b). Considering the common scattered response of CFRP/epoxy joints [6], the reported results remain consistent. In all trials, the load increases linearly, peaks, and then initiates macroscopic crack propagation (softening), leading to gradual load reduction with increasing displacement. DCB tests ceased when the crack reached about 80% of the bonded region, and the remaining bondline was fractured with a wedge. Fluctuations in load during softening mainly correspond to the crack path. Crack growth can involve cohesive fracture of the adhesive, mixed failure of the CFRP substrates (involving intralaminar and interlaminar fracture) or both [8].

The associated R-curves of DCB specimens appear relatively flat, indicating consistent fracture toughness across the bonded area. Visual inspection revealed that cohesive fracture of the epoxy adhesive was the primary failure mechanism in all tests except B1S1, which displayed a mixture of cohesive fracture of the epoxy and fracture of the

outmost region of the composite substrate (mainly interlaminar). Examples of both mechanisms are shown in the insets of Fig. 3(b) and the corresponding toughness was  $(1.14 \pm 0.16)$  kJ/m<sup>2</sup> (interlaminar) and  $(1.95 \pm 0.17)$  kJ/m<sup>2</sup> (cohesive fracture of the adhesive), which are in excellent agreement with those reported by Dehaghani [5]. The average toughness obtained herein is  $\cong 1.5$  kJ/m<sup>2</sup>. This value is deemed satisfactory and is larger than that reported in previous work for bonded CFRPs comprising the Araldite 420 A/B (Huntsman) toughened epoxy [6].

ENF test results are depicted in Fig. 3(c) and exhibit consistent initial linear responses across all tests, with deviations observed post-macroscopic crack formation. The most significant deviation occurred during testing of B1S4DR01, which was attributed to fracture of the CFRP after visual inspection of fractured surfaces. Tests were halted as crack fronts approached the loading pin location, preventing further loading to avoid bulk damage to the upper CFRP substrate. Corresponding R-curves in Fig. 3(d) remained consistent and comparable. However, none of the tests achieved steady-state crack growth, as the R-curve consistently rose with crack length. Hence, only initiation fracture toughness was provided for each ENF test. The average toughness, excluding B1S4DR01, was  $(1.28 \pm 0.05)$  kJ/m<sup>2</sup>. Following mechanical testing, the samples were separated using a wedge, and an inspection of the fracture surfaces revealed a dominant cohesive fracture in the crack propagation region, as shown in the inset of Fig. 3(d).

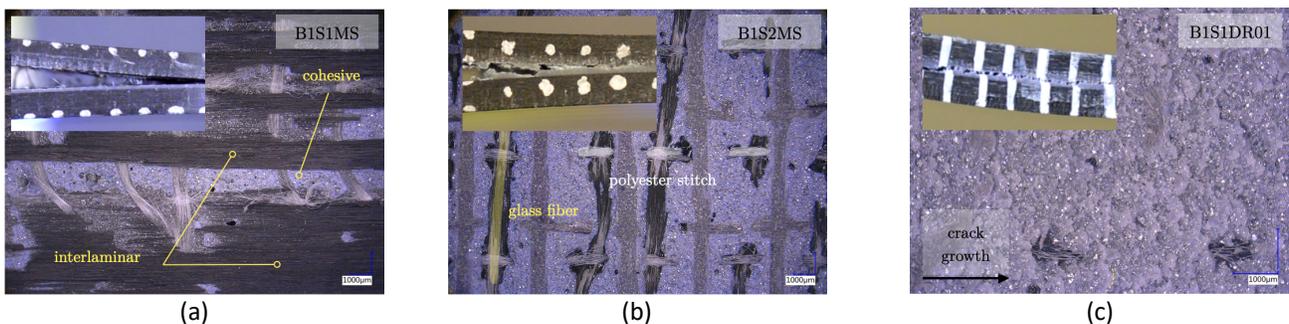
Figure 4: Typical images of crack propagation taken in situ using a CCD camera, and corresponding fracture surfaces. The images refer to (a) interlaminar fracture in a DCB specimen; (b) cohesive fracture in a DCB; (c) cohesive fracture associated to Mode II crack propagation in a ENF test.

A more detailed examination of the failure process involved capturing CCD images in situ during mechanical tests and utilizing images obtained via an optical microscope. These results are presented in Fig. 4. As previously mentioned, cohesive fracture of the adhesive layer predominated in most DCB specimens, except for B1S1MS, which experienced failure of the CFRP substrates (mainly interlaminar), as depicted in Fig. 4(a). For the remainder of the DCB specimens, a representative image of the fractured surfaces is provided in Fig. 4(b). Close observations reveal the exposure of glass fibers, polyester stitches, and carbon fibers. Furthermore, the images confirmed weak adhesion at epoxy/glass and epoxy/polyester interfaces, evident from their exposed state with minimal epoxy traces (though epoxy presence cannot be completely ruled out based solely on visual inspection). Additionally, the imprint of glass fibers from the mating substrate is visible. Small spots of substrate fracture observed in all specimens confirm that such fractures involve peeling of small portions of the outermost surface layers of CFRP.

mechanisms differed, dominated by ductile fracture with parabolic microcracks, attributed to intense plastic (shear) straining of the adhesive layer, as seen in Fig. 4(c). Notably, the rubber-modified 3M 07333 epoxy consists of an epoxy matrix with dispersed synthetic rubber. During straining, rubber can form micro-voids that grow through plastic deformation and coalesce until final fracture. Interestingly, a substantial process zone was observed in ENF tests, as shown in the inset of Fig. 4(c).
